HiLINE CORROSION PROTECTION

SEMI-AUTOMATIC PARKING SYSTEM

TrendVario 4000, 4100, 4200, 4300, 6100, 6100+, 6200+, 6300, 6300+

1. System-specific corrosion protection

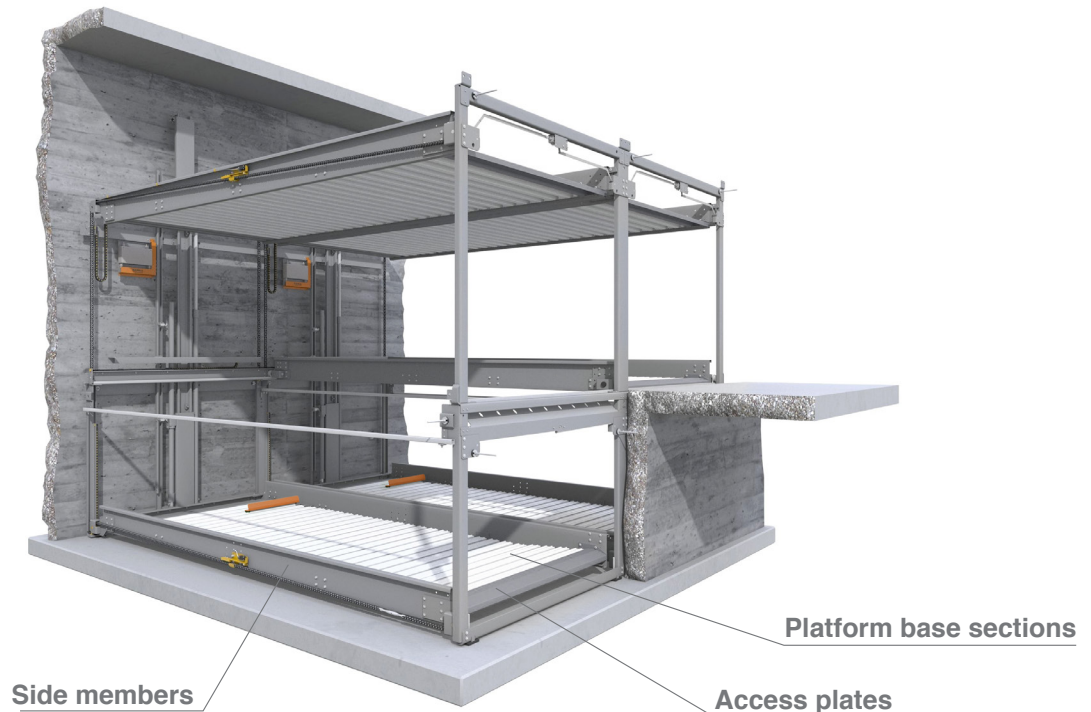
Platform base sections:

Hot galvanized according to DIN EN ISO 1461, layer thickness min. 45 µm.

Side members:

Hot galvanized according to DIN EN ISO 1461, layer thickness min. 55 µm.

Cross members:

Gate frame sliding gate/Vertical gate:

Frame construction with one (sliding gate) / two (vertical gate) vertical centre stay bar(s) made from aluminium extrusions. Anodized, layer thickness approx. 20 µm.
